Arà Zarian

Abstract: The Armenian legislation is currently protecting and preserving architectural monuments, archaeological sites, and minors' artistic forms of art like *xač'k'ars*. Unfortunately, there are several cases of precious wall paintings preserved inside religious buildings (*Tat'ev, Lmbatavank', K'obayr, Mastarà*) being damaged during architectural monument restoration. In recent years, there has been a lot of interest in study, conservation, and restoration of wall paintings in Armenian churches; however, there is one terrible reality to report: the neglect and abandonment of the protection and safeguarding of visible wall paintings for many bureaucratic and logistical reasons, as well as reasons for complete indifference for the destiny of the frescoes. A significant illustration of this negative attitude is the chapel of the Armenian monastery of *K'obayr*. After many years of abandonment, the Armenian Ministry of Education, Science, Culture and Sport made a move and began a campaign of studies and restorations in collaboration with the Polytechnic of Milan, to restore the buildings and wall paintings. Restoration work on the *K'obayr* chapel has been put on hold s

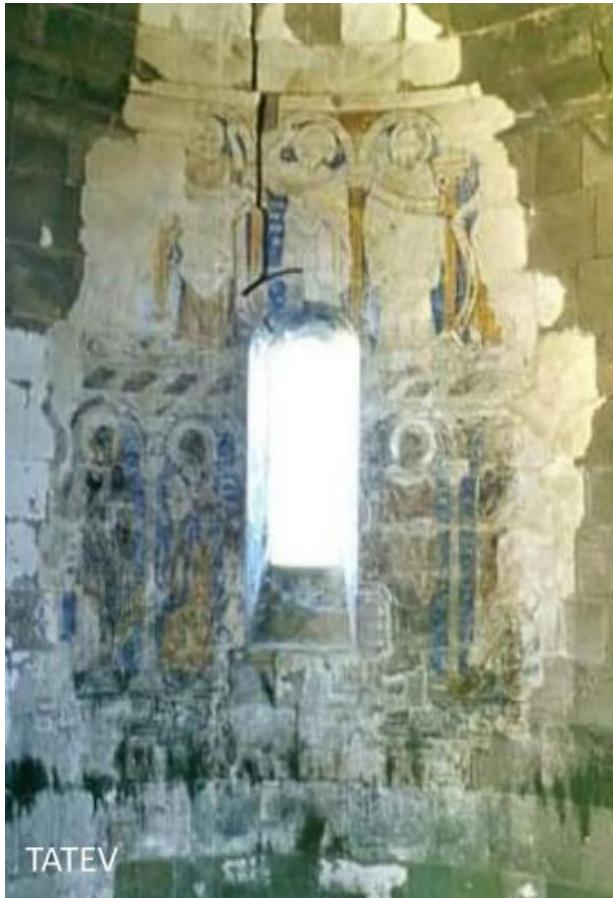
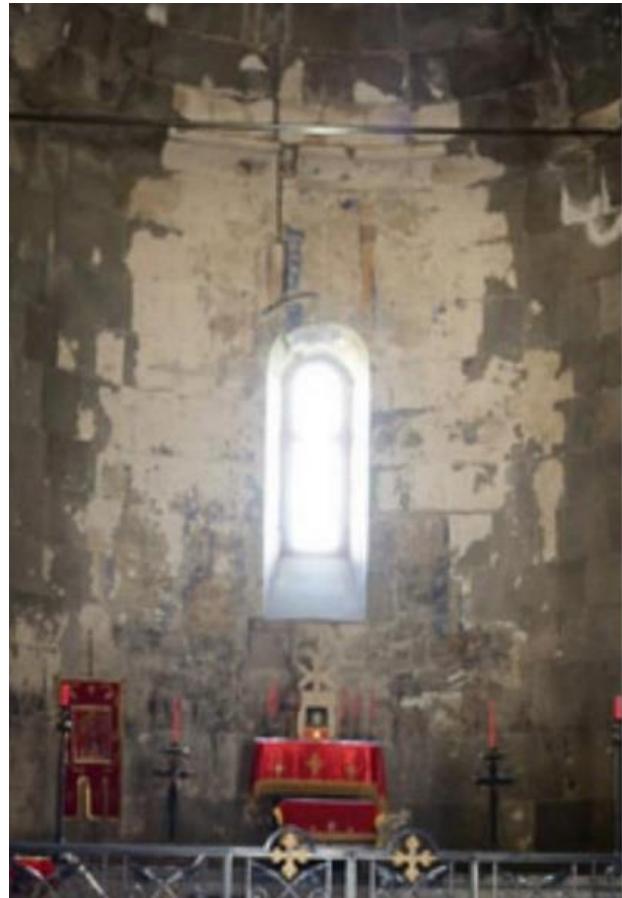
Fig. 1. 10th-century wall paintings of the main altar of the Saints Peter and Paul church in the Tatev monastery complex before and after restoration of the church

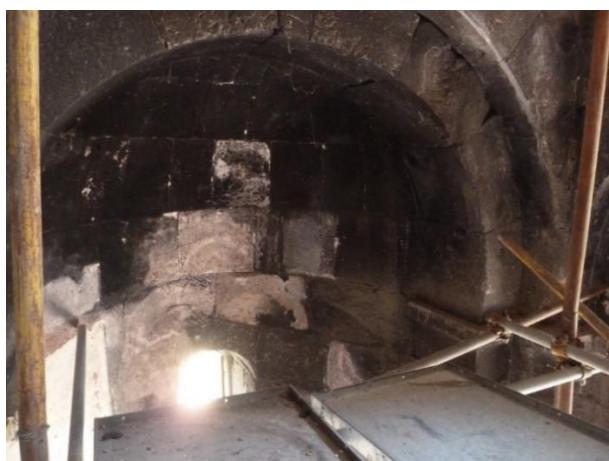
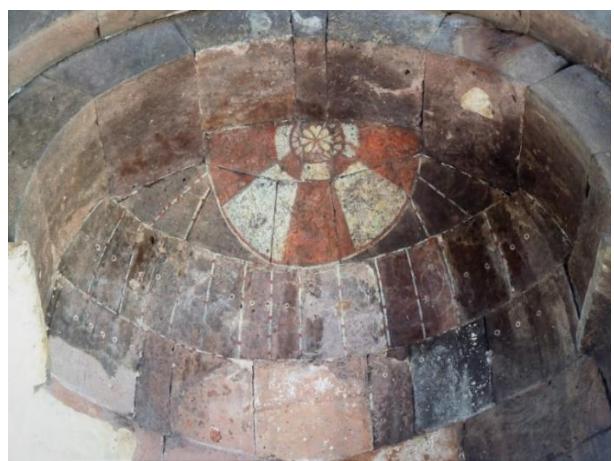
Fig. 2. Depicts the process of removing historical plaster from the southern dome of the Saint Stephen Protomartyr Church in Lmbatavank to clean the walls, as well as our discovery of a 7th century mystical illustration in 2024

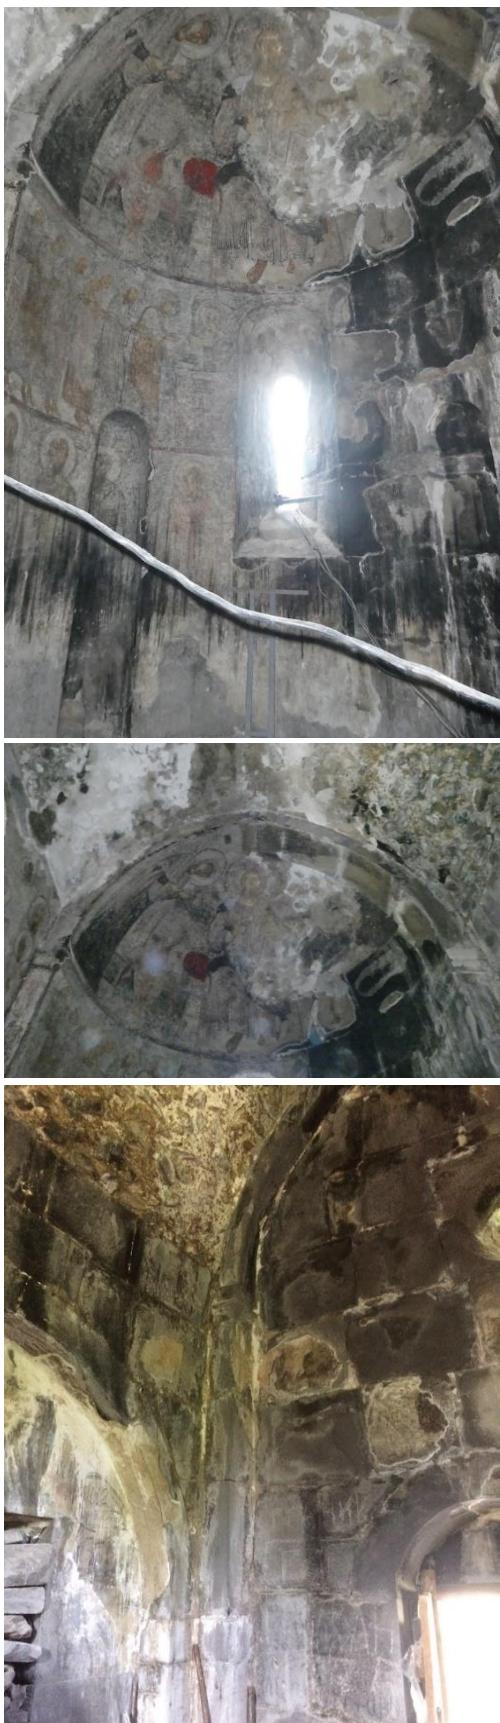
Fig. 3. Due to the poor restoration of the roofing of the Kobayr chapel, as well as the infiltration of rainwater throughout the decades, high-value frescoes of the 12th century were lost

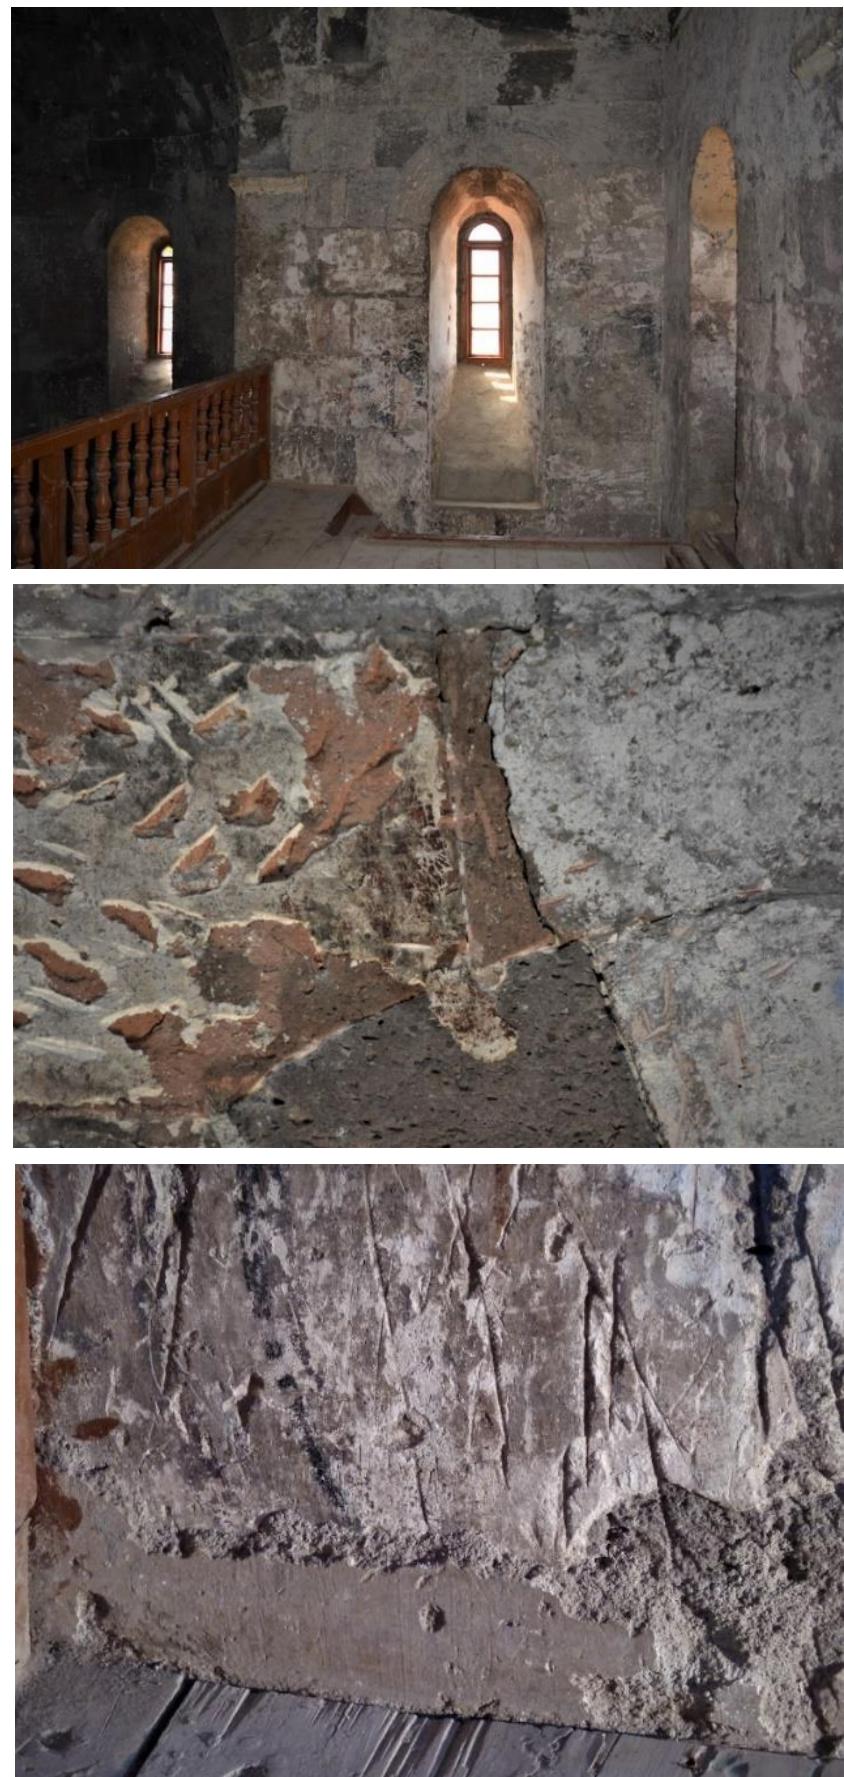
Fig. 4. Damaged parts of the 7th century frescoes on the walls of St. John Baptist Church in Mastara, caused by Soviet plastering and its removal in the 1990s

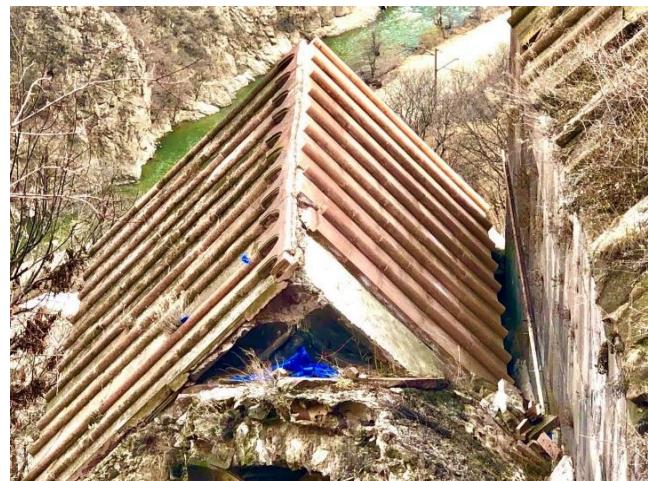
Fig. 5. *The bad condition of the Kobayr chapel's roof*

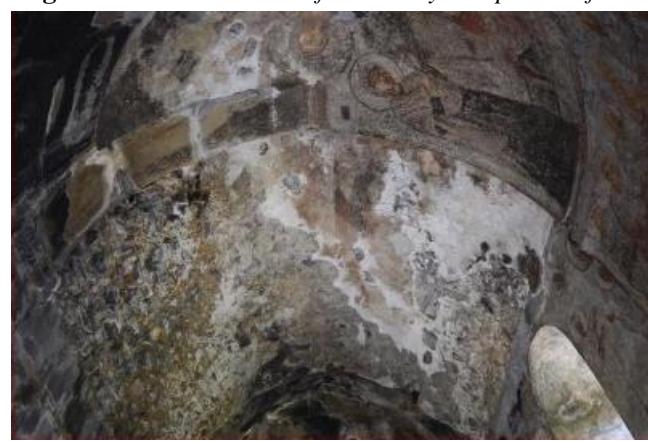
Fig. 6. Ara Zarian and Christine Lamoureux's 2021 project to clean, repair, and conserve the frescoes of the Kobayr chapel, waiting for the gable roofs to be restored

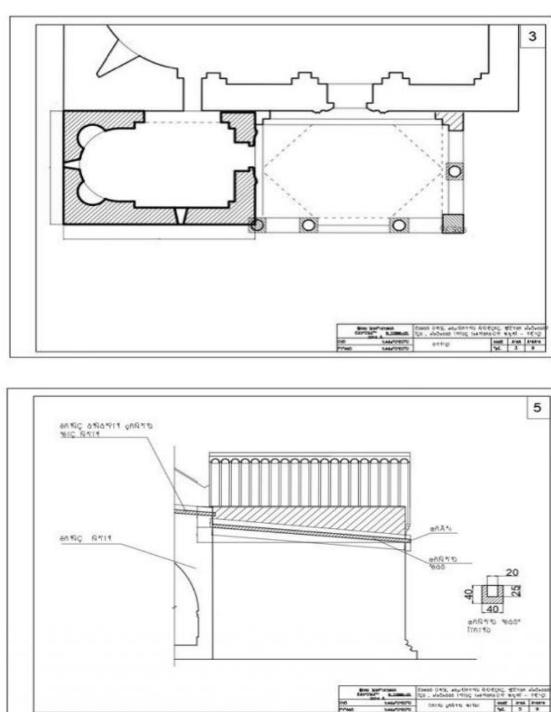
Fig. 7. Architect Gor Mikayelyan's restoration project for the Kobayr chapel roofs was proposed in the 1990s but never implemented

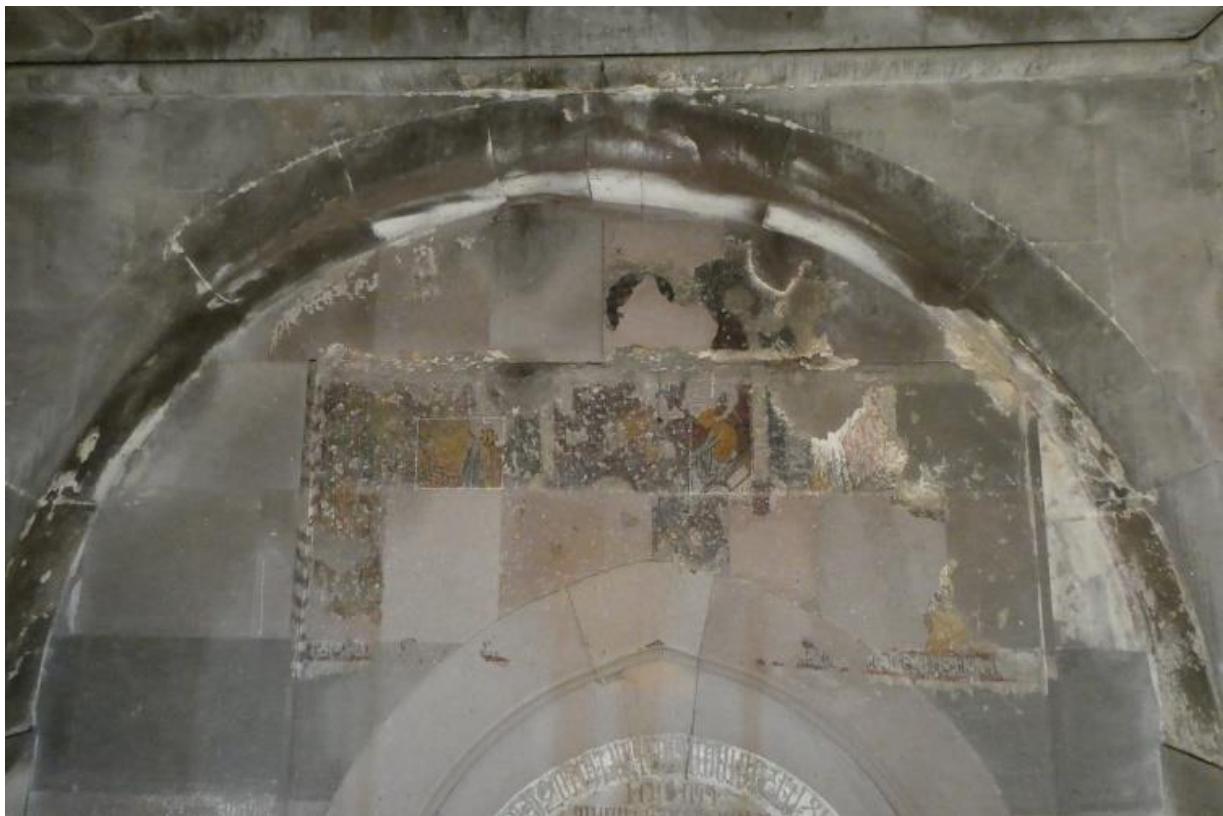
Fig. 8. Fragments of a mural painting dated 1235 were found on the upper part of the entryway to Holy Mother of God Church from the Harich Monastery

The competent authorities displayed the same indifference in the case of Haričavank, a symbolic monument of medieval Armenian architecture, where the few fragments of the depiction of Hodegetria cannot be salvaged and preserved since a small piece of the roof has not been maintained and waterproofed (Fig.8). The Ministry has said that unless the roof situation is fixed, it will be impossible to propose a project to restore wall paintings, which will disappear in the meantime. We have been requesting this minor intervention for three years, which might be done in a single day by using specific materials to waterproof the link between the gavit's roof and the Mother Church's roof (Fig.9). Although the Haričavank' monastery is the property of the Holy See of Ejmiacin, our project for cleaning, consolidating and conserving the remains of the wall painting must be

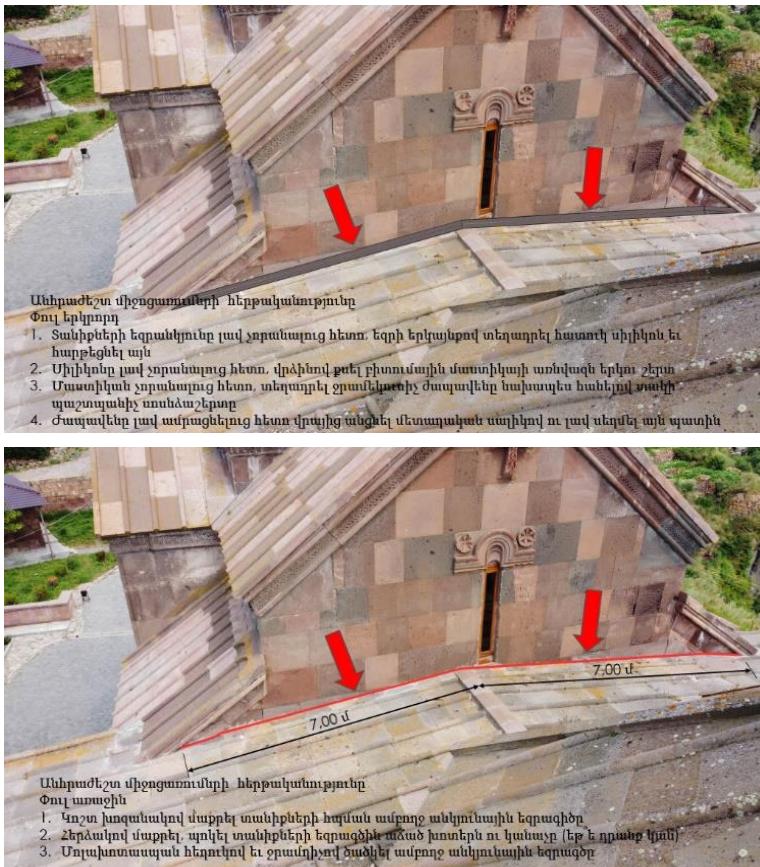
Fig. 9. Architect Ara Zarian's proposal for waterproofing the gable roof of Harichavank courtyard in 2021 is awaiting approval from the Mother See of Holy Etchmiadzin

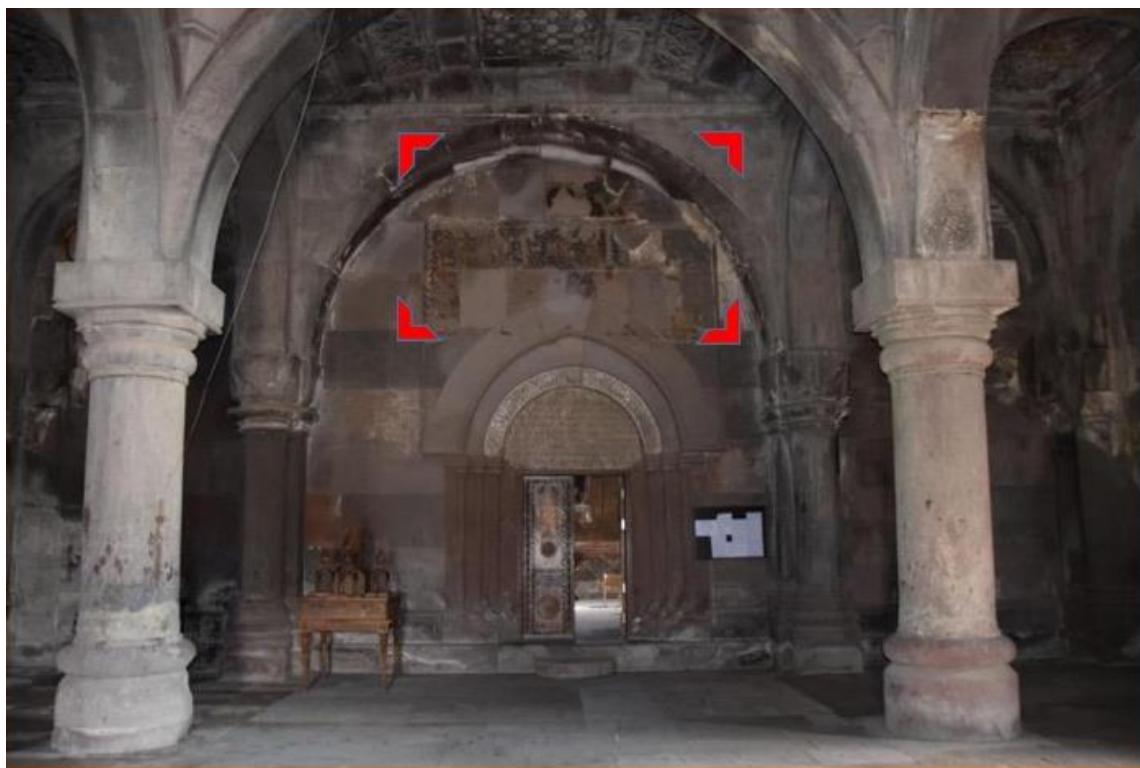
Fig. 10. Ara Zarian and Christine Lamoureux's project to clean, maintain, and restore the Harichavank frescoes, approved by the RA Ministry of Education, Science, Culture, and Sport in 2024, is now awaiting approval from the Mother See of Holy Etchmiadzin

presented both to the Ministry's Scientific Commission and the Holy See's Commission of Architects. The issue is that one rejects the other while we await the project's presentation (Fig.10). We proposed an intervention on our initiative to waterproof the external covering above the wall of the internal painting. We are awaiting communication to leave for Yerevan and present our proposal, for which we are willing to invest the necessary funds. We did not receive a single invitation during the entire year of 2023.

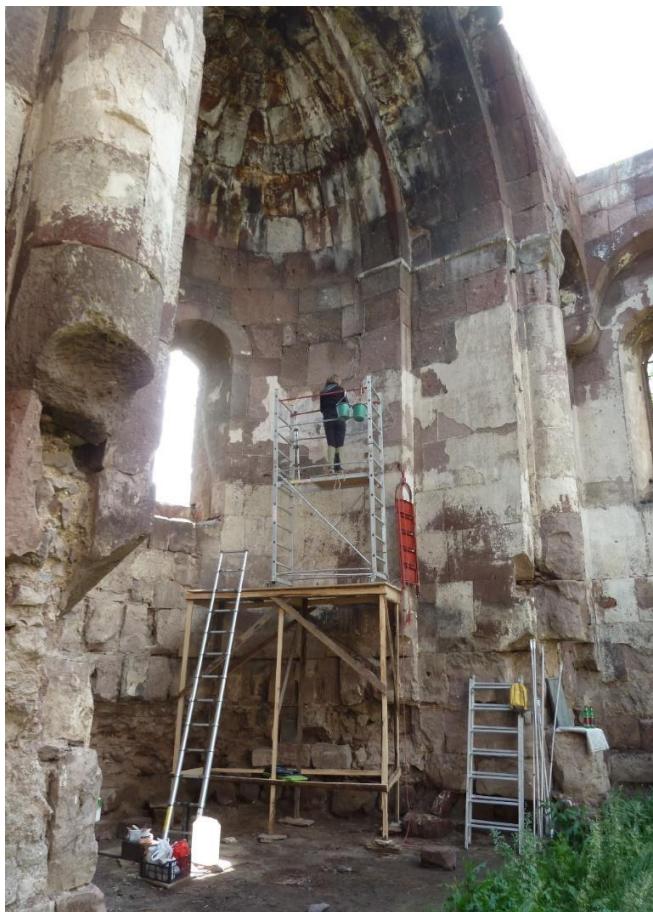
Fig. 11. The restoration of a section of the 7th-century fresco preserved on the south wall of the main altar at St. George Cathedral in Artik

In the Mother Church of Art'ik, where the dome does not exist, in 2017, a section of the fresco cycle in the main altar from the 7th century was restored (Fig.11). For the best possible conservation of the restored paintings, we asked for the construction of a small provisional cover of the K'obayr type to be built, but it was never made. The wall paintings are now practically outside, in the open air (Fig.12).

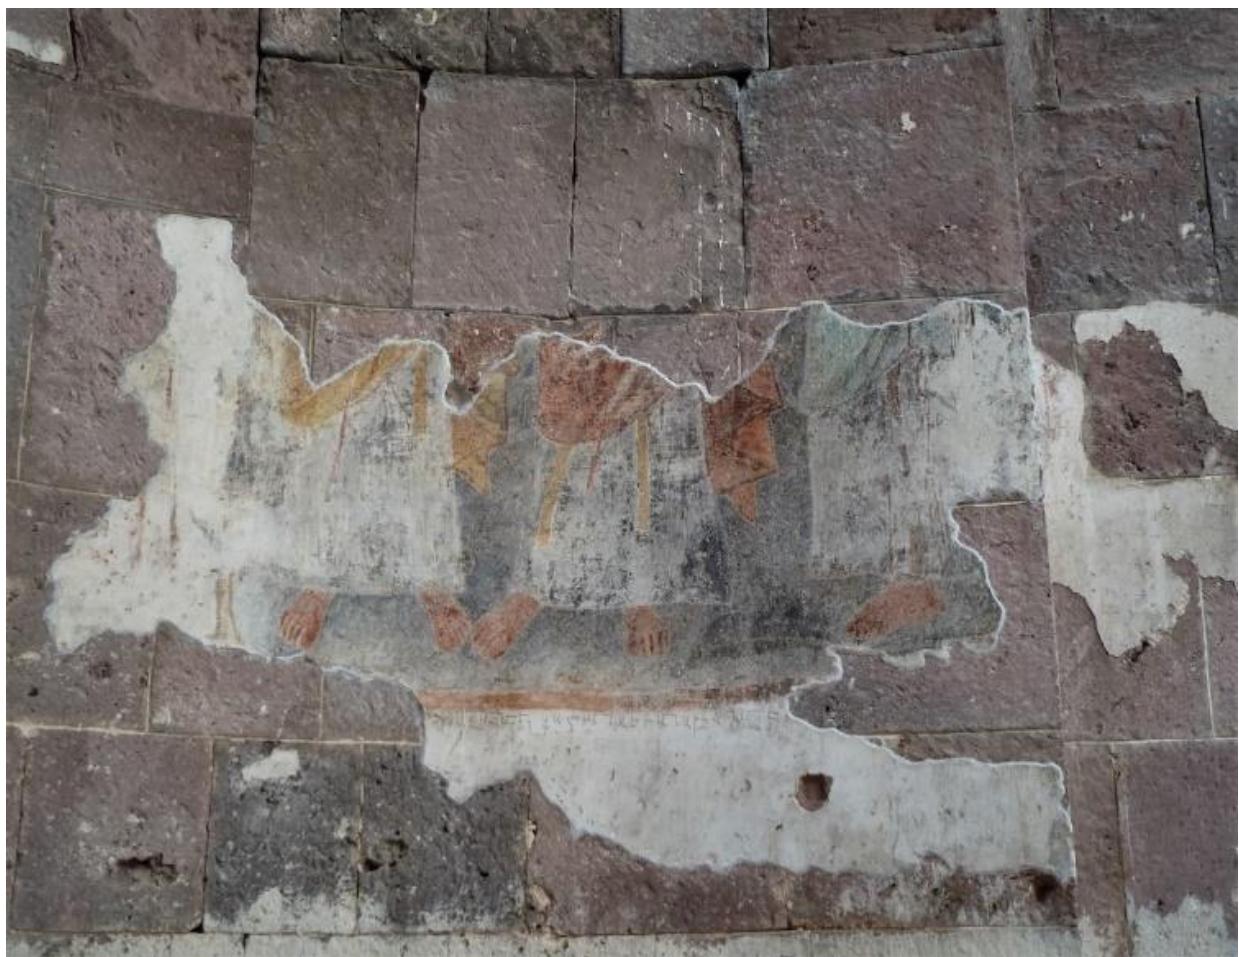
Fig. 12. The same mural after restoration in 2016

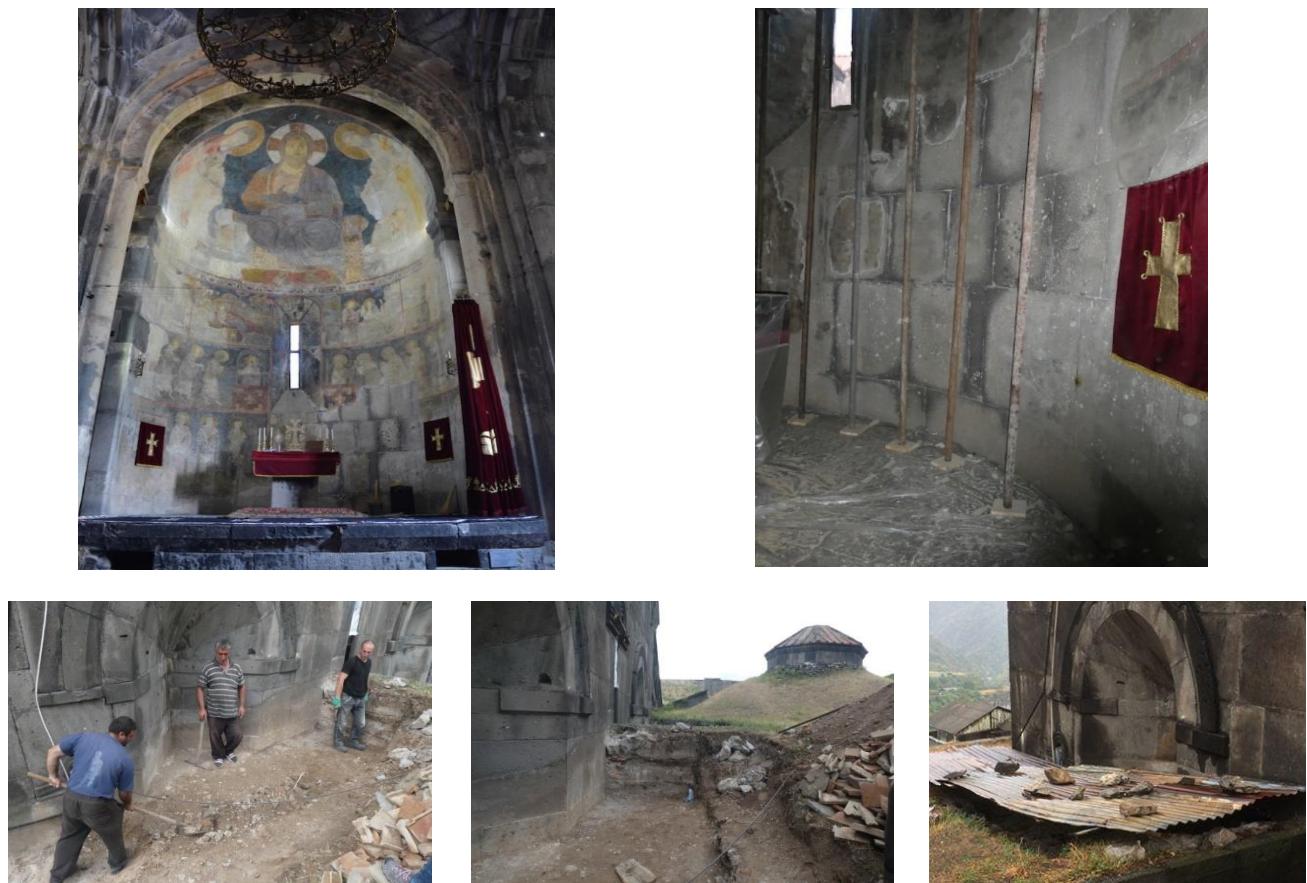
Fig. 14. The damages caused by humidity to the wall of the mural painting restored by Ara Zaryan and Christine Lamoureux in 2019 of the main altars of the Holy Sign Church of the Haghpat Monastery complex, as well as the necessary measures and the unfinished status as of today

In 2019, in Hałbat Monastery, a UNESCO World Heritage Site, we restored the wall paintings in the main altars, which had significant rainfall infiltration in the southeastern part due to the leaning external gallery (Fig.13). We notified all required authorities and obtained permission to begin soil excavations and waterproofing. When the wall paintings were restored, the Archbishop and Dean of the Diocese of Gugarac' Sepuh Č'uljyan passed away, and everything stopped. I wrote, sent letters and contacted the Holy See of Ejmiacin, but nothing came from it. A waterproofing project was proposed by removing the soil layer for permanent intervention; however, construction work was stopped due to the solution of a temporary cover made of sheet metal taken from the Rectory fire. For the past four years, rain has infiltrated and washed away parts of paintings from the third register of the main altar of the Holy Sign church restored by us. The indifference and lack of care for this important Armenian heritage, as in the case of a *xač k'ar* installed in the masonry inside a church, is considered a historical monument and therefore protected and conserved, but the mural painting on the church's wall no. After 4 years, rain still fell on the sheet metal retrieved from the rectory fire (Fig.14).

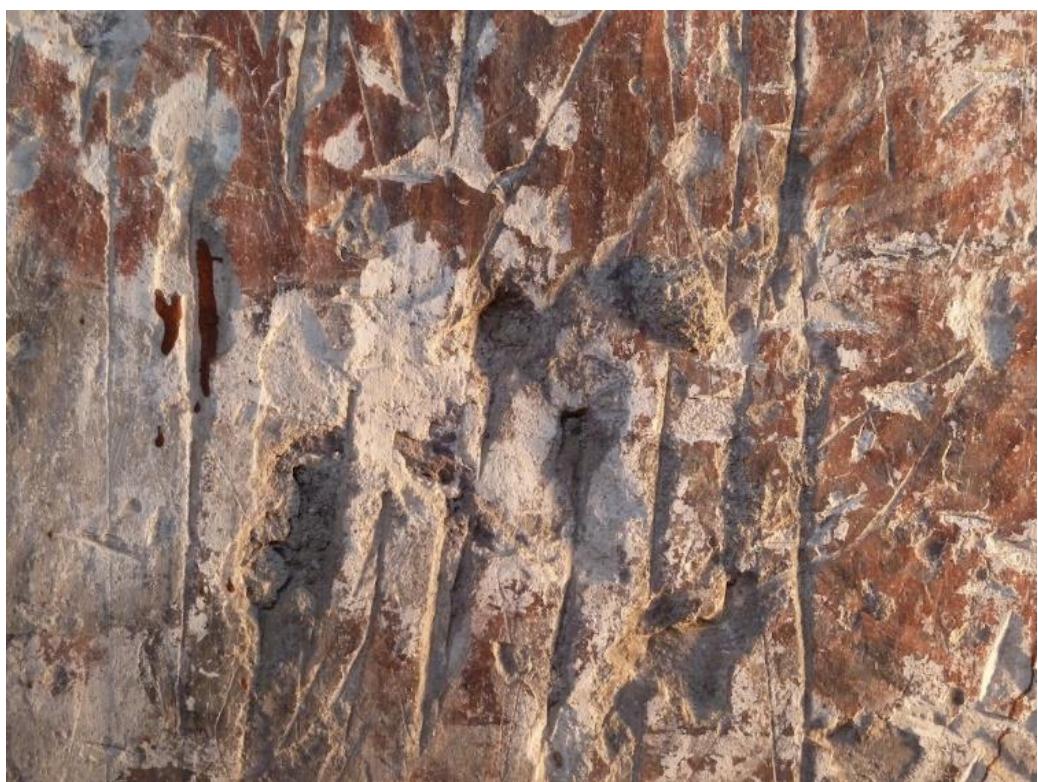
Fig. 15. An example of the brutal destruction of the fresco remnants discovered in 2015 by Ara Zaryan and Christine Lamour of St. John Baptist Church in Mastara

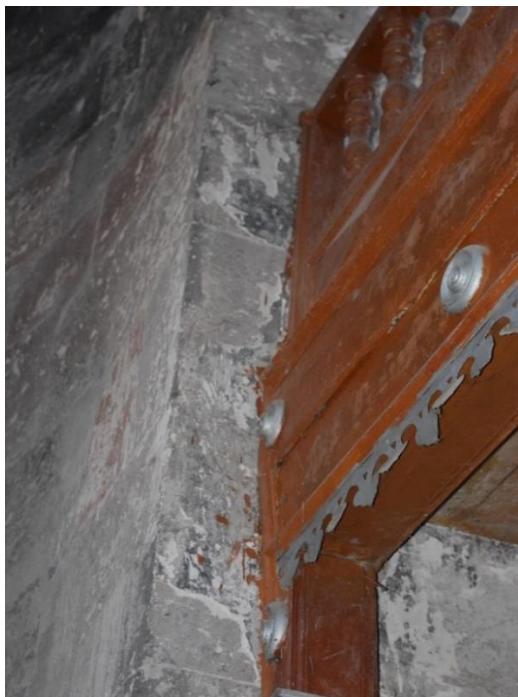
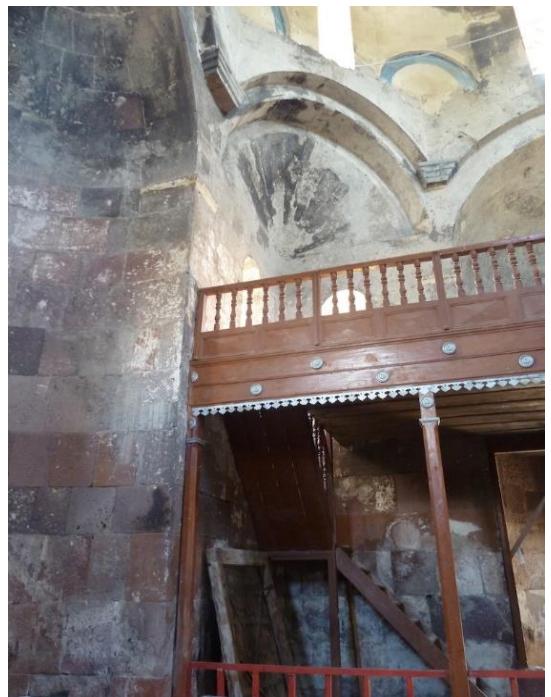
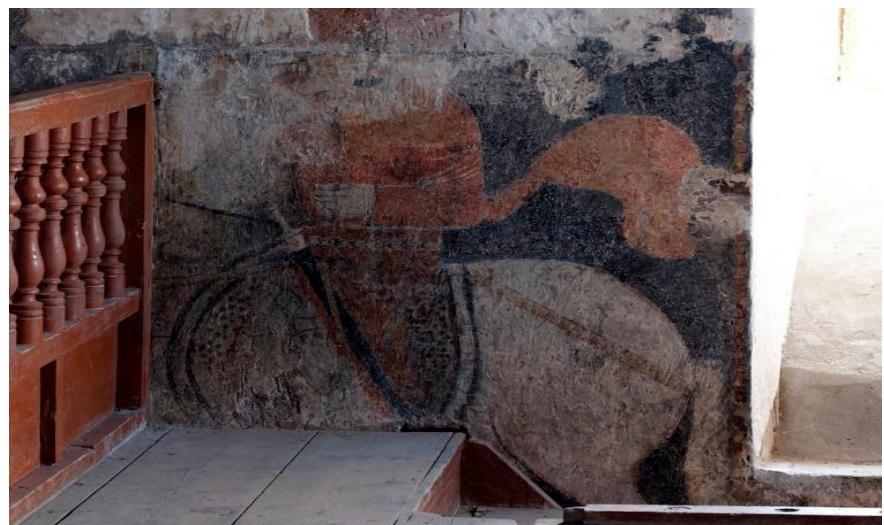
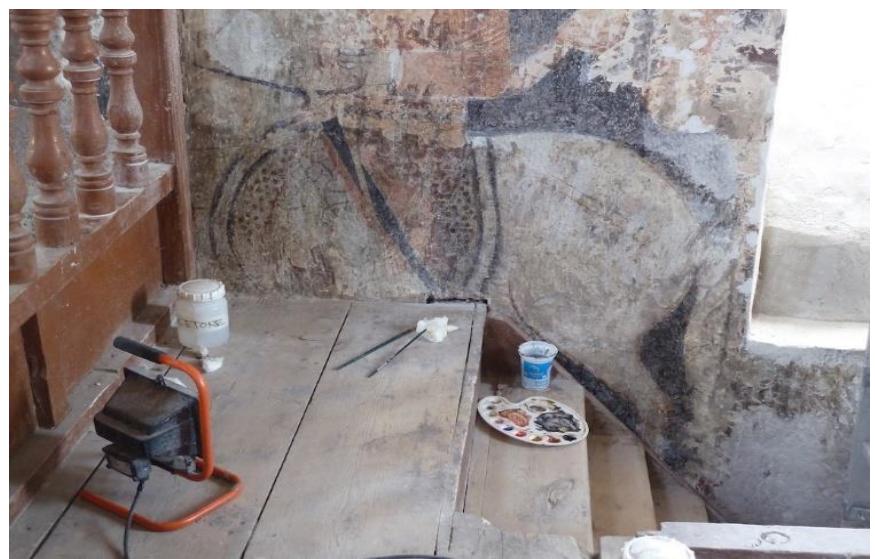
Fig. 16. The fragments of a fresco from the 7th-century can be found on the church's southern wall beneath the wooden wheels of an 18th-century lodge. Ara Zarian and Christine Lamoureux restored the wall painting in 2016

In 2017, we discovered the remains of wall paintings on the southwest corner of the church of Saint John Baptist in Mastarà. After completing the research and studies, we presented the cleaning, consolidation, and restoration project to the Armenian Ministry of Education, Science, Culture and Sport, and it was authorized and approved. While doing the cleanup operation, we discovered that after the church reopened to the faithful state in 1993, during the Soviet period, this church was adapted to a grain warehouse, and metal tools were used to eliminate the mortar lade, seriously damaging the remains of fresco fragments hidden under the mortar (Fig.15). Toward the end of the 18th century, during the occupation of Armenia by Tsarist Russia, a wooden mezzanine was built in the church of Mastarà, in the western apse, to house the choir after the church's conversion to an Orthodox rite. The fresco was damaged during the construction, and the wooden structure covered a part of the Holy Knight that we discovered. In 2017, we presented the project sketch to the Ministry of Culture to detach the staircase from the wall and complete the fresco (Fig.16). I never got a response.

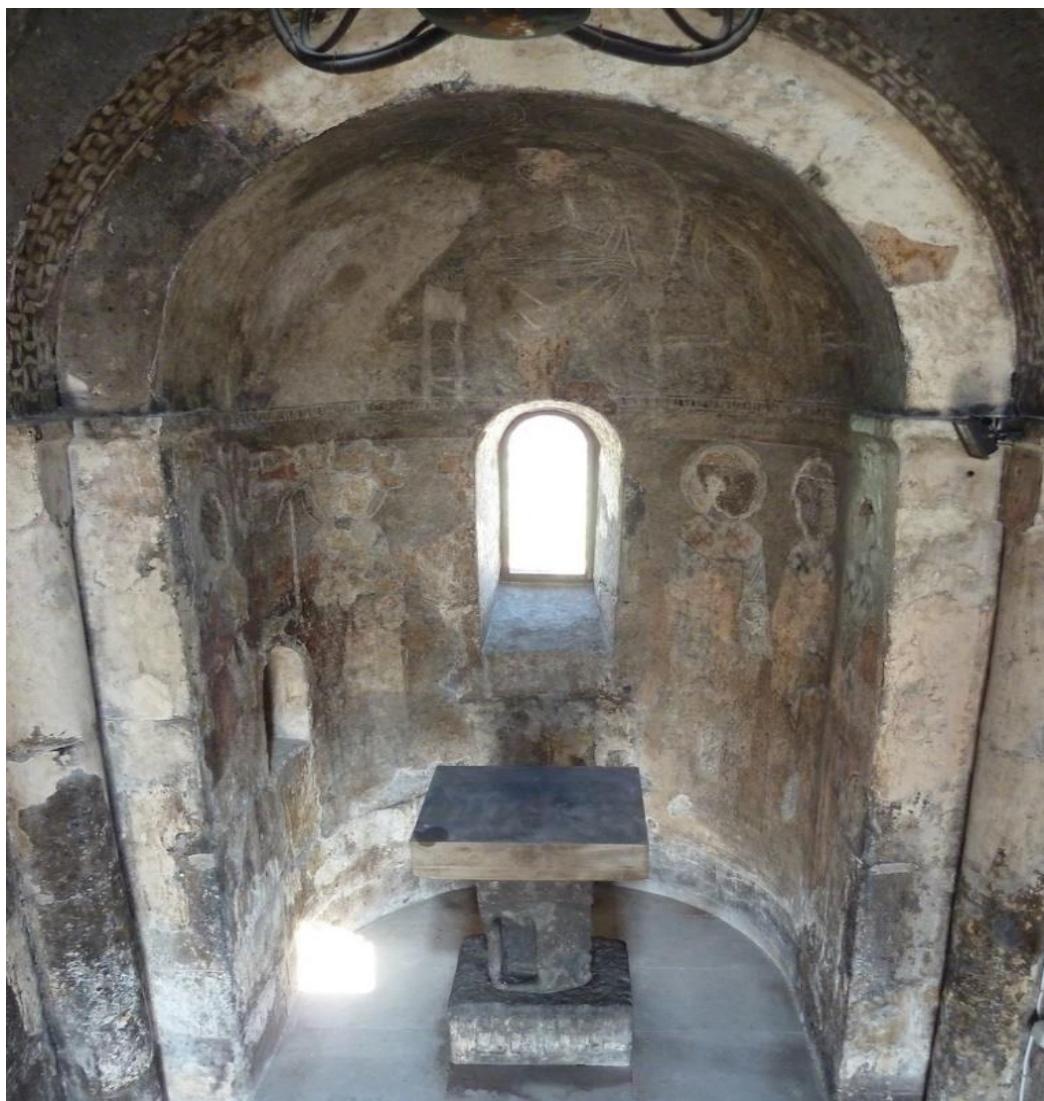
Fig. 17. After completing the works of cleaning, fixing, and conservation restoration of the frescoes on the main altar of St. Holy Mother of God Church of Karmravor in 2016

In 2016, we cleaned, consolidated, and restored the fresco cycle of the Surb Astvacacin church in Karmravor (Fig.17). In 2018, at our own expense, we decided to prepare illustrative panels with photos and texts in Armenian and English, as well as explanations of the various QR code works. The panels have

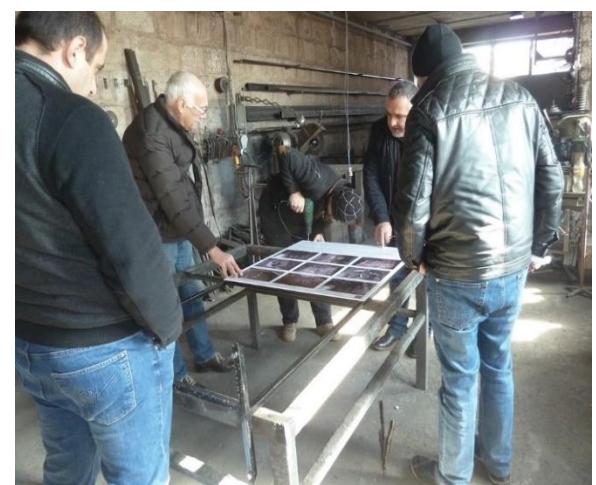
Fig. 18. The process of preparing bilingual explanatory panels near the frescoes restored by us

a metal frame and are printed on rigid PVC (Fig.18). After preparing all the panels, we rented a vehicle and took them to all the churches. In 2021, we reported that the illustrative panel in Karmravor was destroyed with the intention of obtaining metal profiles and building a plate for lighting candles hidden behind the *xač'kar* (Fig.19). This was because it was no longer possible to light candles in the church to protect the restored frescoes. My project included building a new external altar layout for candle lighting by the faithful, together with the reconstruction of the portico destroyed in the 1990s. An entirely free idea was never considered (Fig.20).

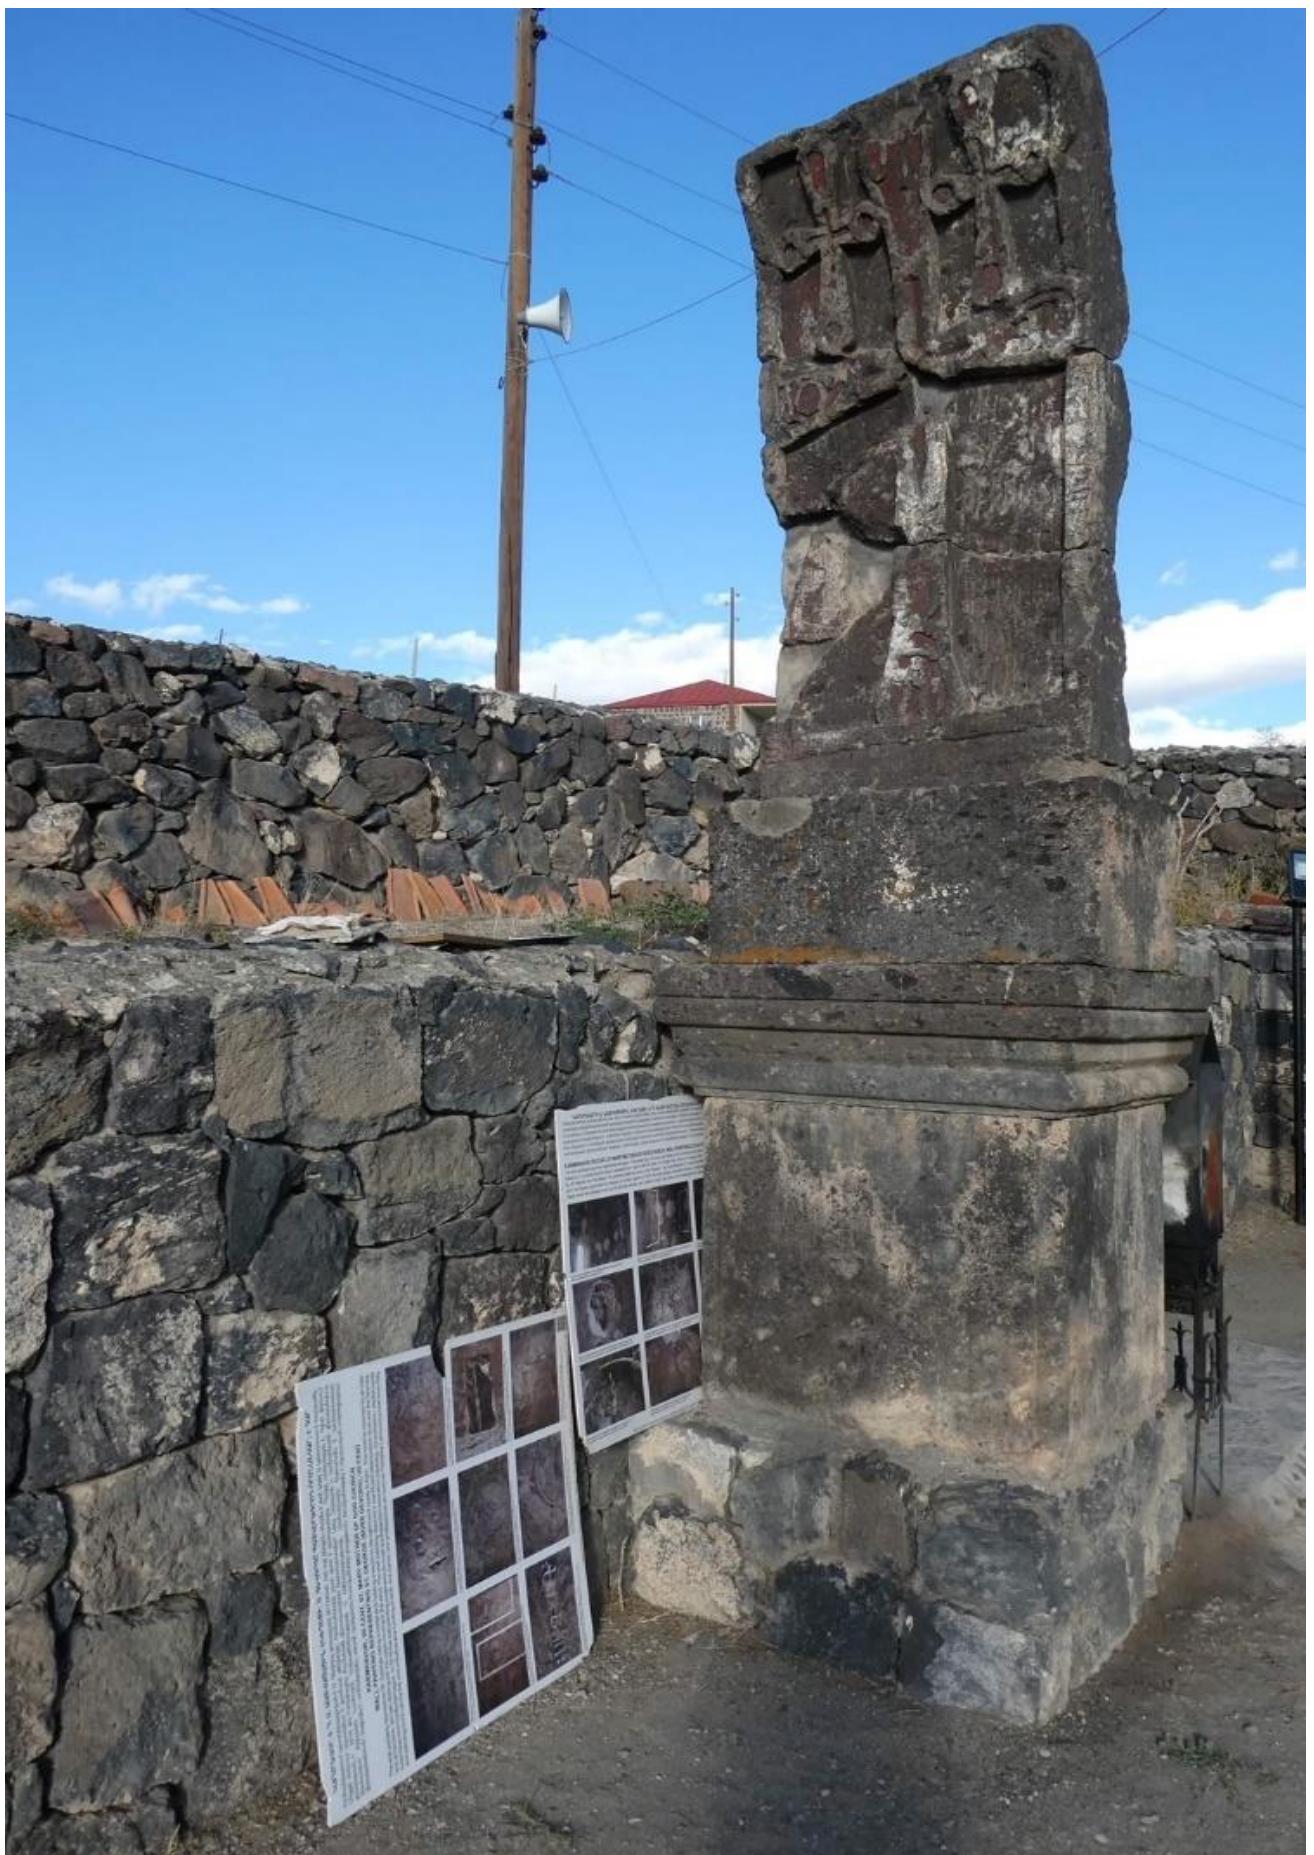
Fig. 19. 2022, after destroying the Crimson's explanatory panel and building a pool of candlelight from its metal rods

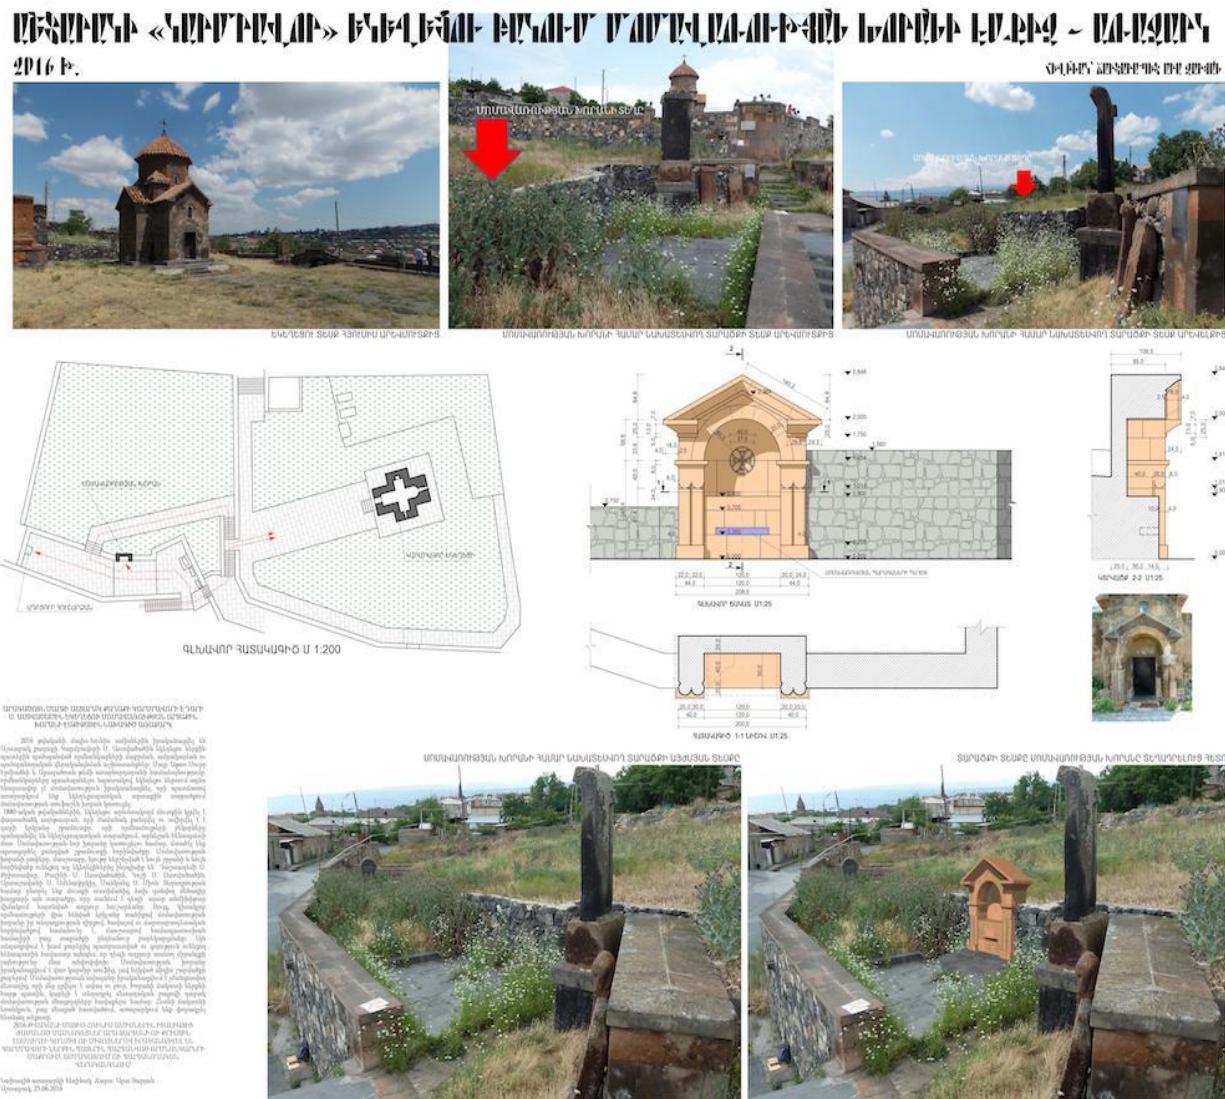
Fig. 20. After restoring Karmravor's murals, architect Ara Zarian proposed the unrealized candlelight altar project

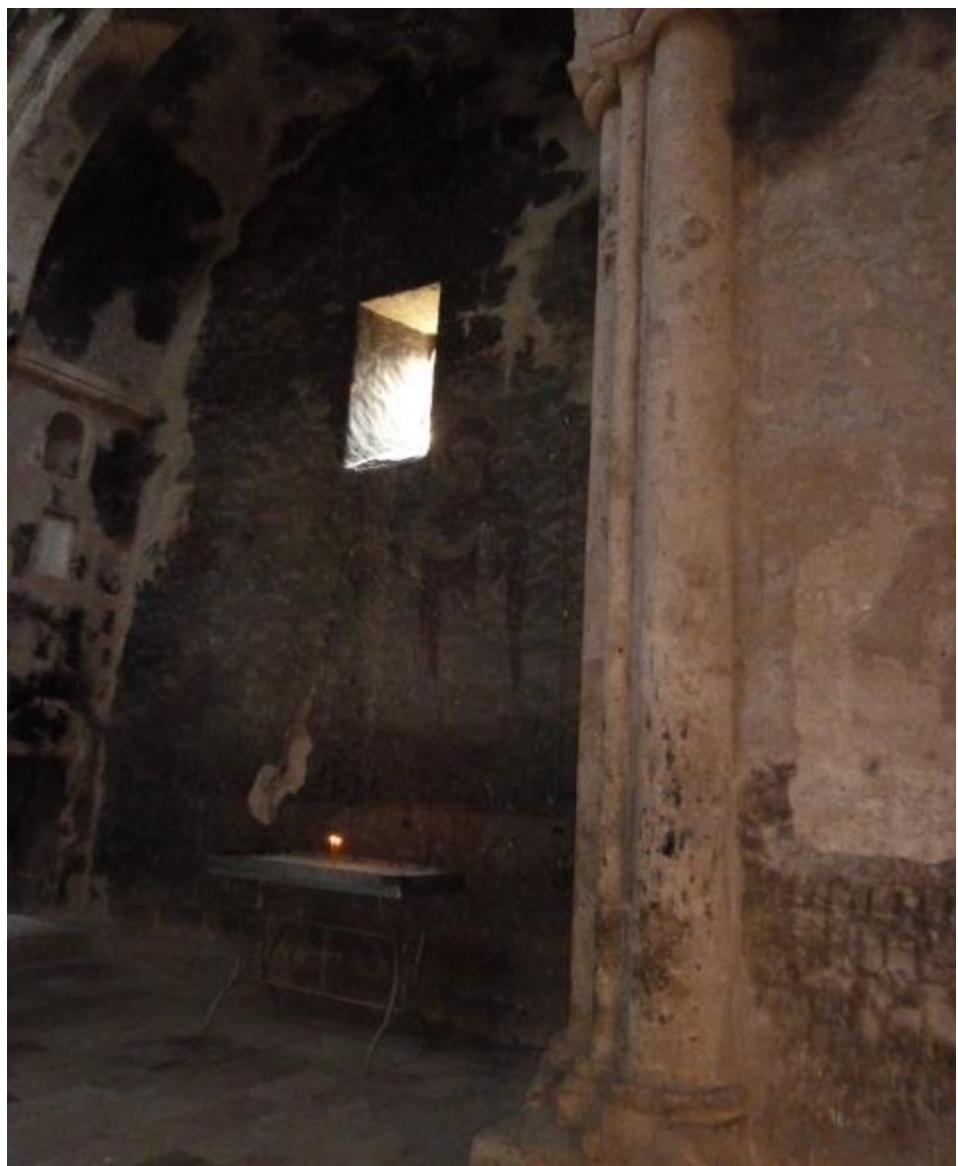
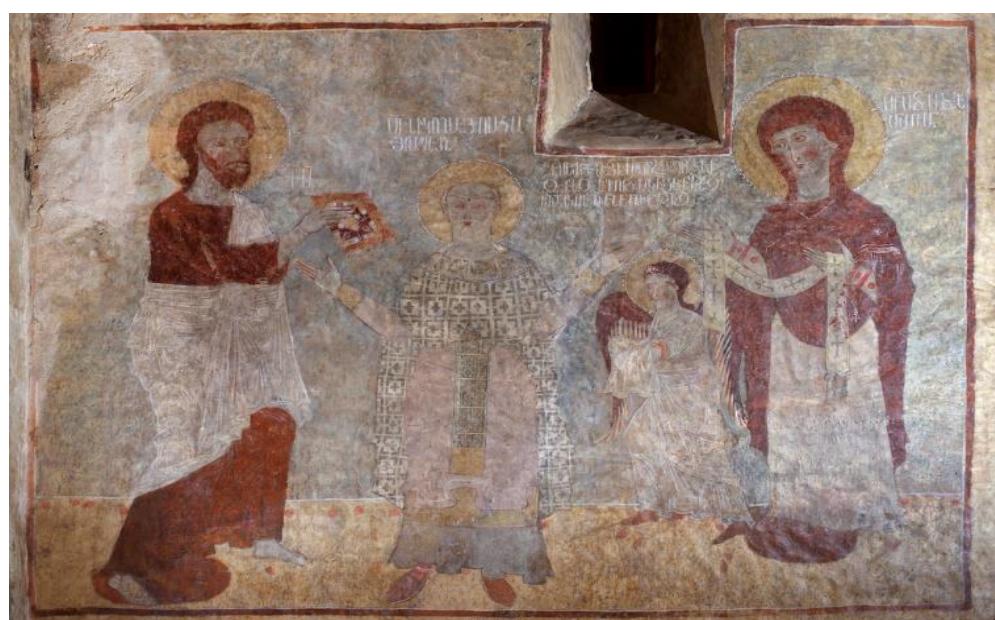
Fig. 22. Before and after restoration of the 1297 mural on the south wall of the Cathoghike Church of St. Holy Mother of God in Dadivank Monastery by Ara Zarian and Christine Lamoureux from 2015 to 2017
