Arà Zarian

Abstract: The Armenian legislation is currently protecting and preserving architectural monuments, archaeological sites, and minors' artistic forms of art like *xač'k'ars*. Unfortunately, there are several cases of precious wall paintings preserved inside religious buildings (*Tat'ev, Lmbatavank', K'obayr, Mastarà*) being damaged during architectural monument restoration. In recent years, there has been a lot of interest in study, conservation, and restoration of wall paintings in Armenian churches; however, there is one terrible reality to report: the neglect and abandonment of the protection and safeguarding of visible wall paintings for many bureaucratic and logistical reasons, as well as reasons for complete indifference for the destiny of the frescoes. A significant illustration of this negative attitude is the chapel of the Armenian monastery of *K'obayr*. After many years of abandonment, the Armenian Ministry of Education, Science, Culture and Sport made a move and began a campaign of studies and restorations in collaboration with the Polytechnic of Milan, to restore the buildings and wall paintings. Restoration work on the *K'obayr* chapel has been put on hold s

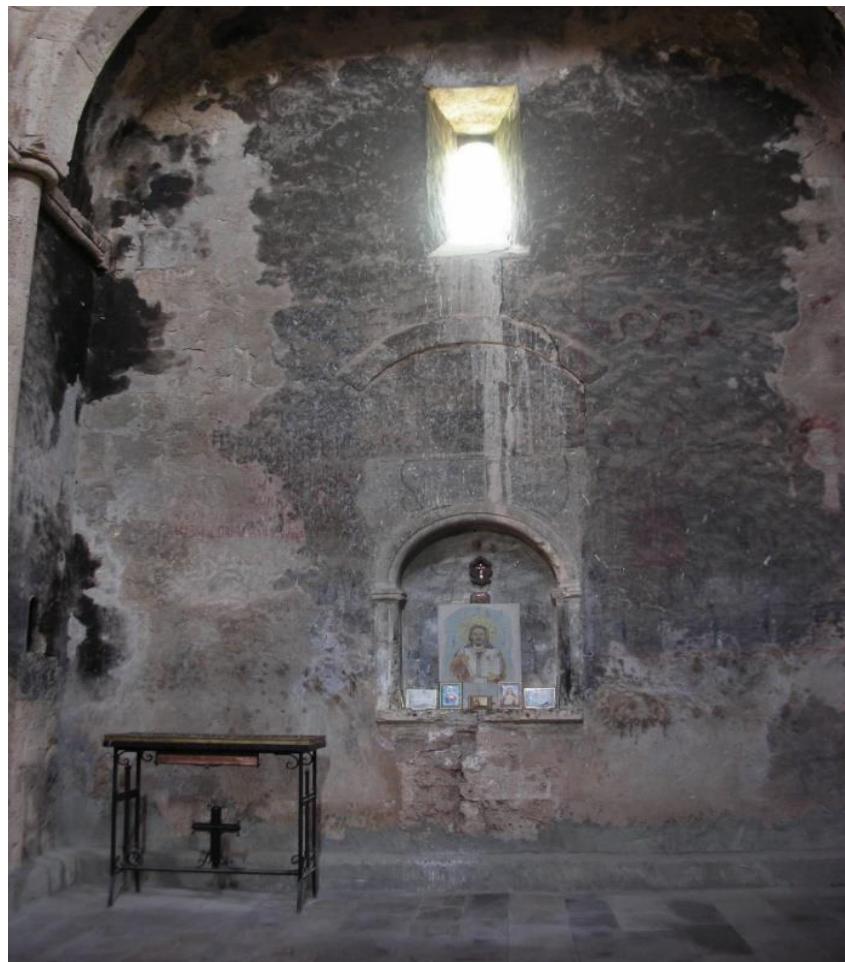
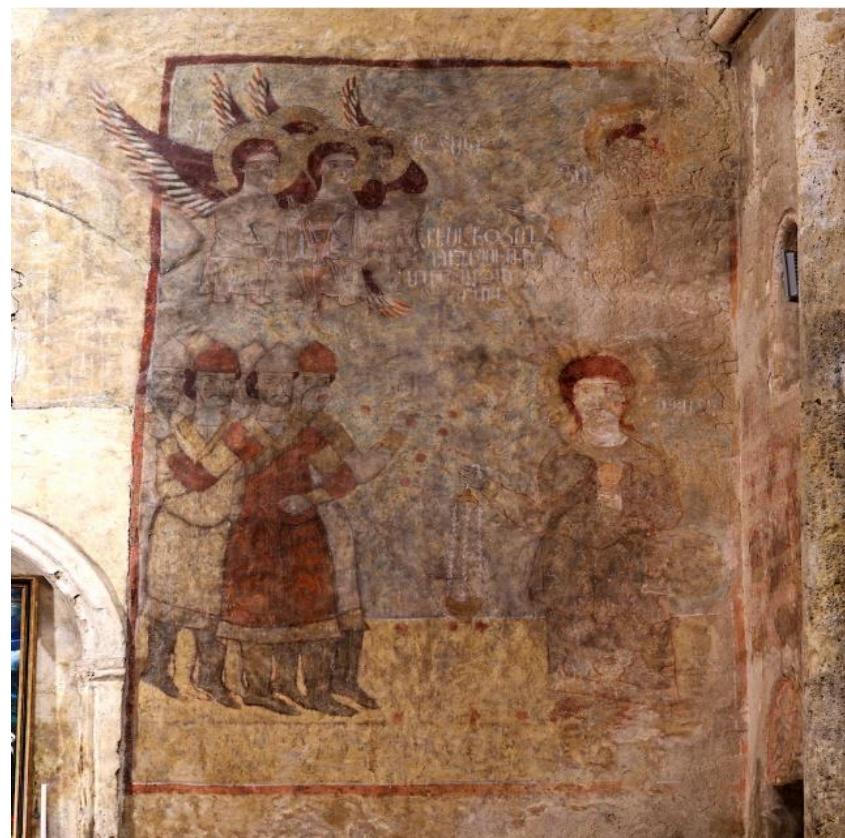
Fig. 23. Before and after restoration of the 1297 mural on the northen wall of the Cathoghike Church of St. Holy Mother of God in Dadivank Monastery by Ara Zarian and Christine Lamoureux

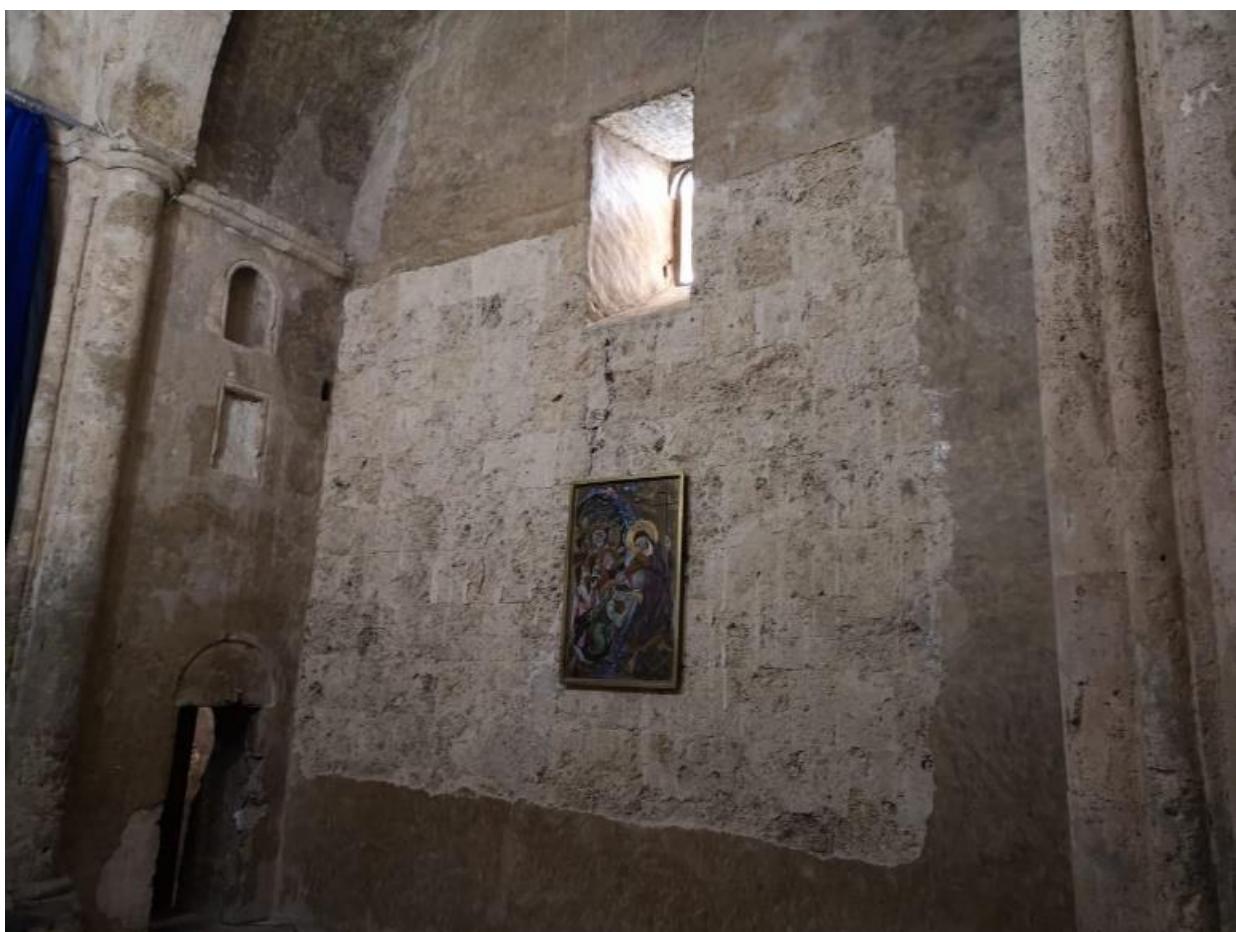
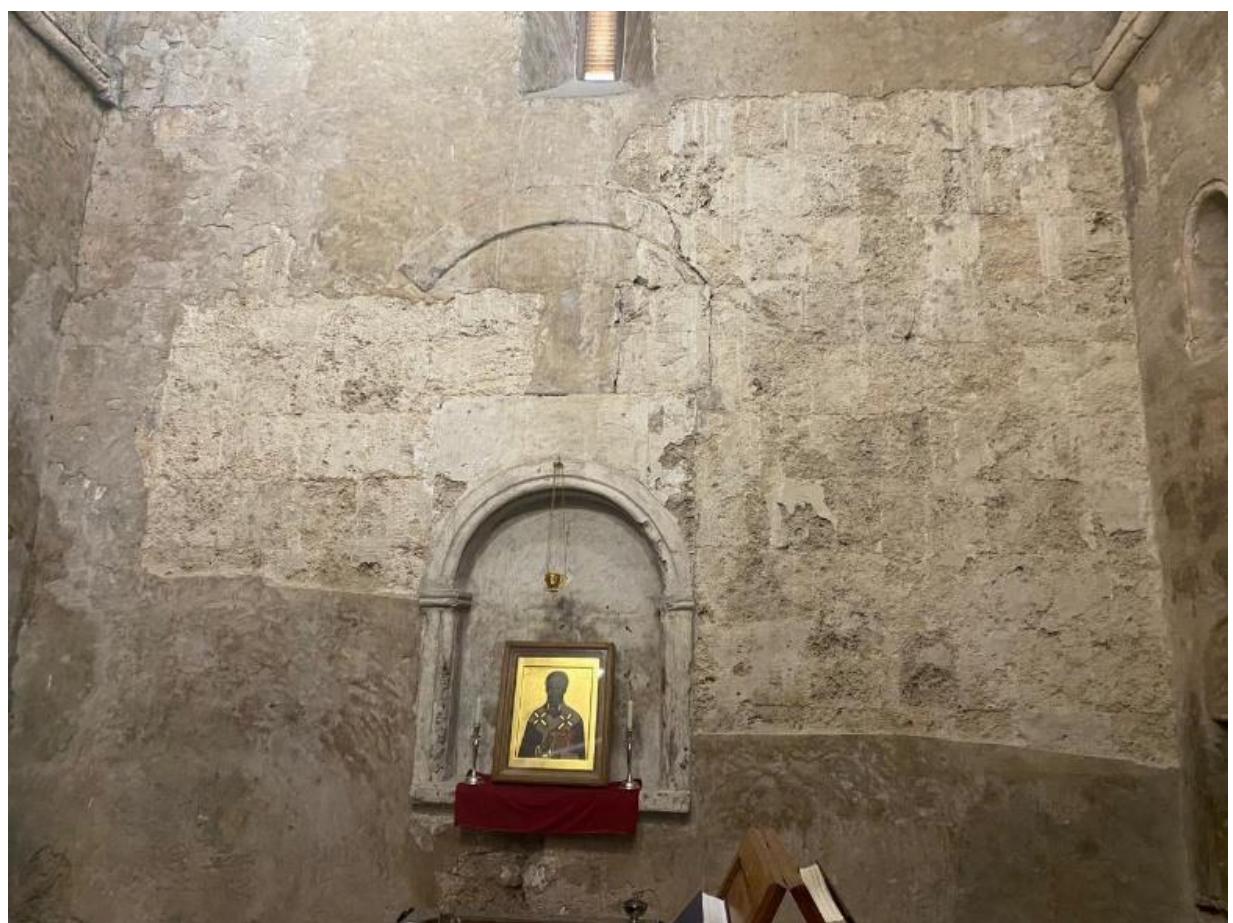
Fig. 24. 2022, after demolishing the mural on the northern wall of the Cathoghike Church of St. Holy Mother of God

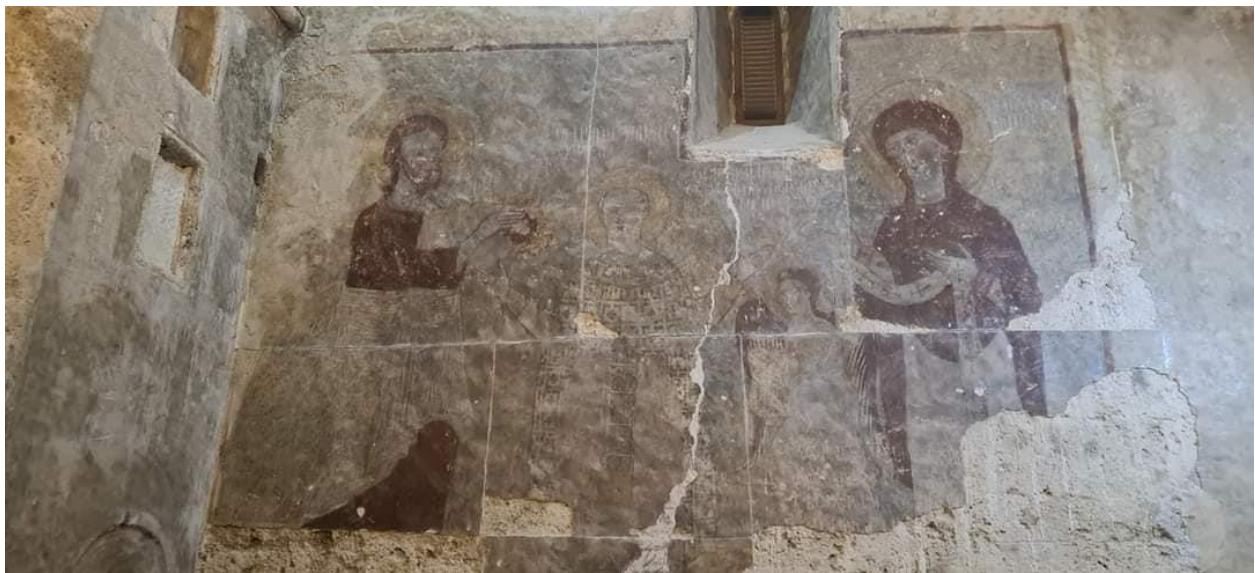
Fig. 25. Dadivank Monastery Cathoghike St. Holy Mother of God Church,
the mural is being removed from the wall for the safety of it
