Abstract: In the paper "Public space built as living heritage", the same authors argued the substantial condition of public space as cultural heritage. In this paper, we are going to discuss heritage buildings that, having lost their original use, undergo a rehabilitation process that includes a change of use. Only a small part of the inherited architectural heritage can be preserved in a more or less consolidated ruined state. The majority, however, has to recover its usefulness through a new function that satisfies new needs. A key concept in this process is the compatibility of the new intended use with the existing building's shell. It is, in general, the recovery of utility that brings architectural heritage back to life. The selected examples are three different-scale buildings, located in Galicia, that have been rehabilitated with changes to their former use.

Study of three cases of building rehabilitation in Galicia

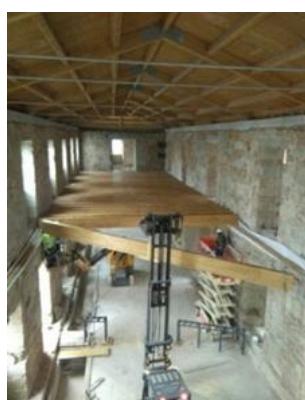
Fig. 9. Timber floors under construction

The construction systems used are similar to the original ones (Figs. 14-17). The load-bearing walls have laminated wood beams, similar to the original sawn wood floors. Any technological update must be respectful and compatible with the original construction systems, both in terms of their technical performance and their appearance (aesthetic and proportional). Likewise, the new air conditioning system is arranged discreetly so that it doesn't dominate a space where it was not traditionally present. The air conditioning system is hidden behind floors or walls to leave the exposed wood ceilings clean. A minimal lighting system is incorporated into the space, suspended without touching the walls, emphasizing the idea of reversibility in the incorporation of these accessory elements.

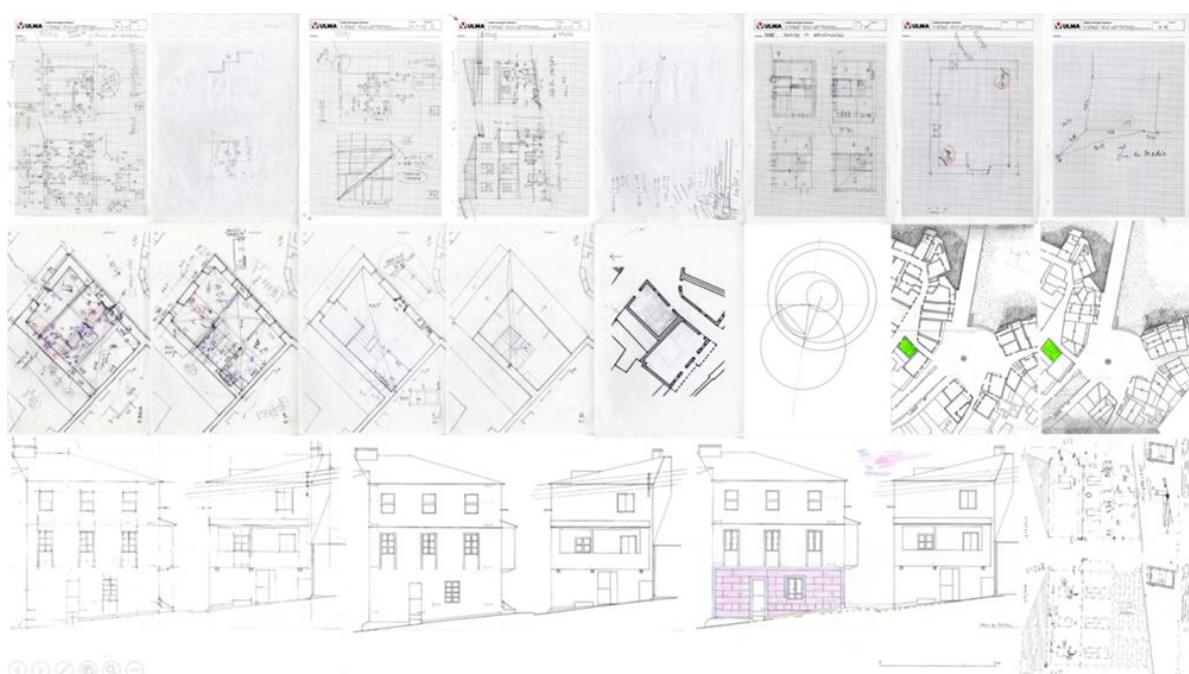
Fig. 40. Planimetric survey of the pre-existing building

The first task of the rehabilitation was to measure the building. In addition, accurately calculate the angle between the facades. It is not an easy task. There are no right angles in the house, and some walls are warped. Then you draw it by hand and measure it again. You do the same with the third dimension. And measure it again. It is like scanning the house, internalizing its dimensions and its character. A work of art (Fig.40).

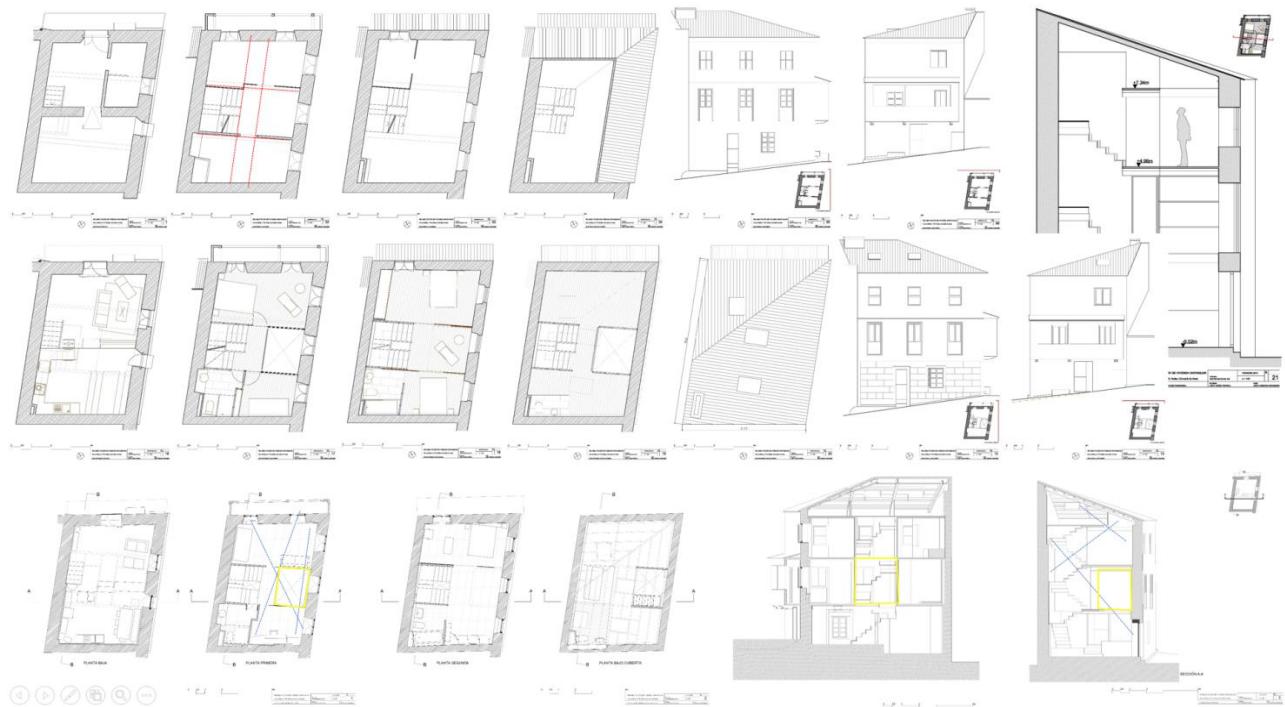
Fig. 41. Plans of the previous state, alternative distribution and definitive solution

Then it is drawn on the computer, which does not add anything new but speeds up the work. Moreover, different alternatives for the organization of the house begin to be designed... (Fig.41).

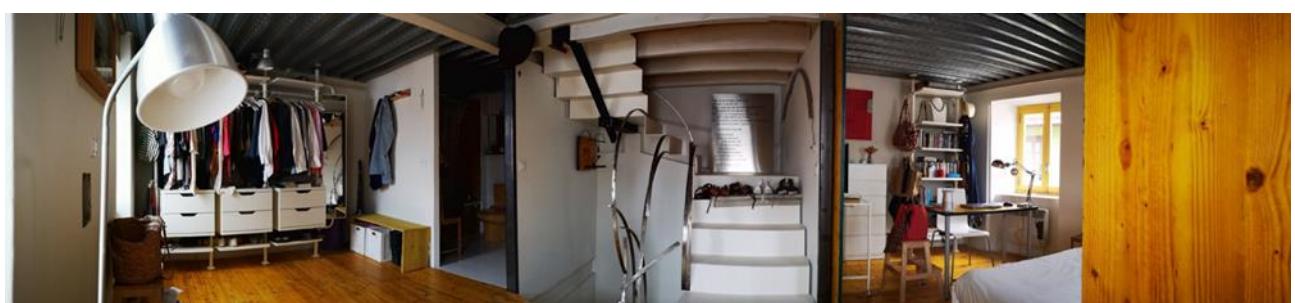
Fig. 46. The second floor, which is an open space with a movable partition

The most difficult part of the rehabilitation project remained: the organization of the interior space and its lighting. We took time to reflect on its design and materialization, and we began the works, within the building envelope, in 2014. As has been said, the key was to break up the box and distribute natural light. This was resolved by placing a **light cube** in the heart of the building, freeing the ground floor from the stable wall, leaving it open and at two levels, using glass partitions on the first floor, and leaving the second floor open with a partition of practicable panels (Figs. 42,45,46).
